LOCKHEED-GEORGIA COMPANY
Manufacturing Research Investigation

ESTABLISH THE GENERAL USE OF CERAMIC TOOLS IN PRODUCTION

INTERIM REPORT

TITLE: ESTABLISH THE GENERAL USE OF CERAMIC TOOLS IN PRODUCTION .

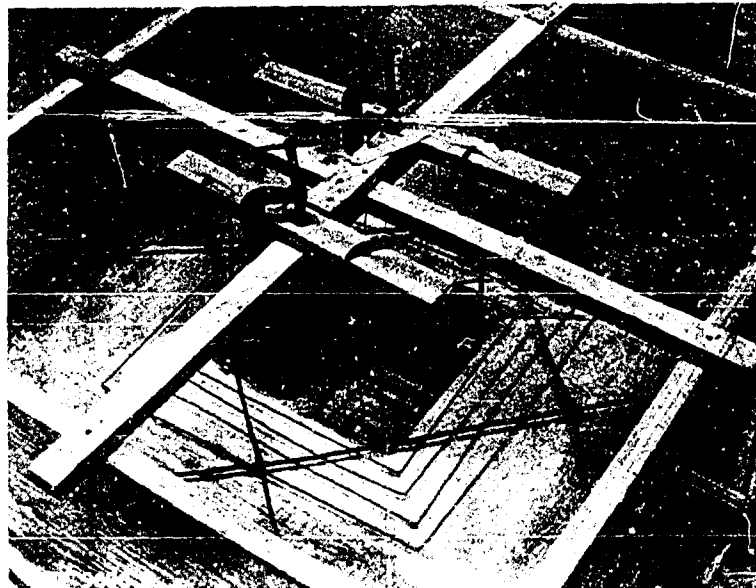
Fig. 2A

Heating element suspension prior to casting punch section of Litter Strap Box tool.

The plaster models were boxed as shown in Figures 2A and B. The heating wires were suspended one half inch above the plaster face. An enlarged Teflon blowout valve was mounted in the boxed die mold for casting into place.

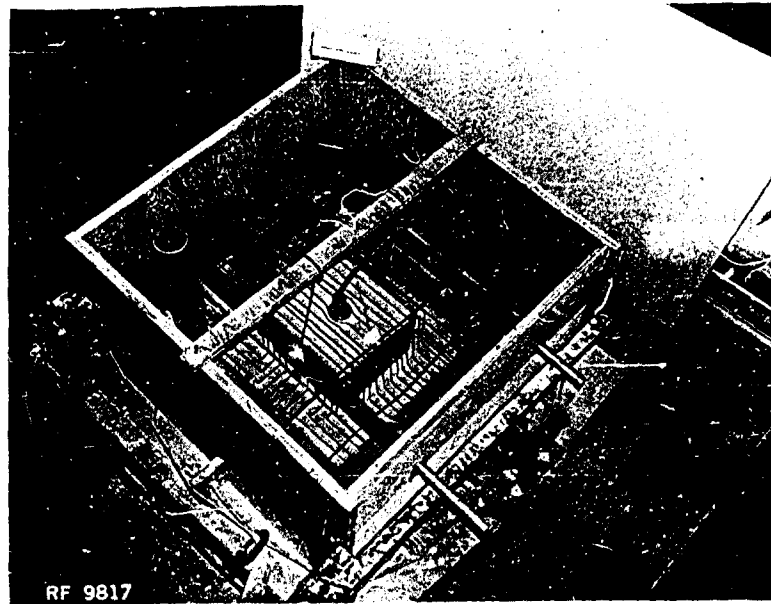
Fig. 2B

Nichrome wire configuration in Litter Strap Box die section. Wires were suspended above the plaster mold with thread.

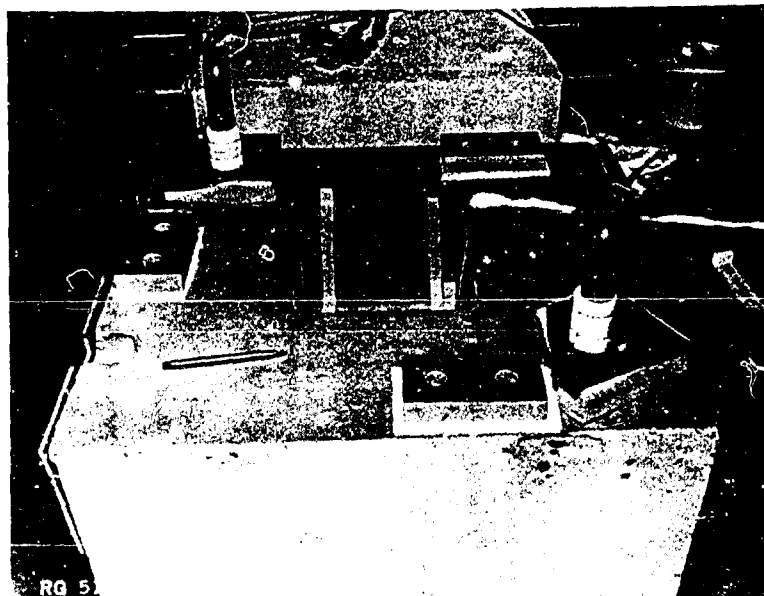
Fig. 3

Setup for potting kiss blocks and Teflon guide bushings. Epoxy was puddled under kiss blocks which were positioned on picture frame of resilient plastic foam, punch was cradled, and then guide bushing potting poured.

Three phenolic kiss blocks were epoxy potted on the die block at the same time the bushings were potted in (see Figure 3).

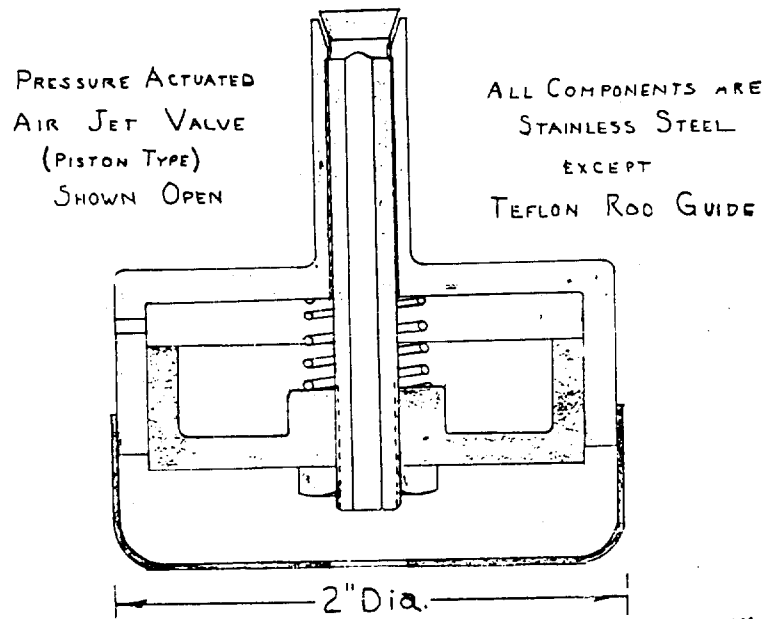
Fig. 5

Drawing of valve assembly used in Litter Box.

A new blowout valve was developed and installed in the punch. A description of the valve appears in Figure 5. This valve worked well on ten sample parts formed in the laboratory press.

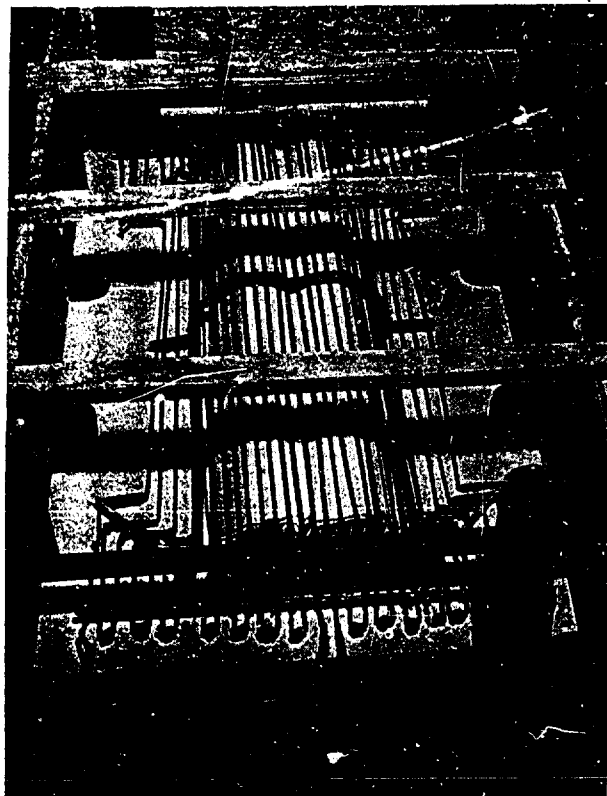
Fig. 6

Mold and heating wire
assembly prior to
casting Radar Junction
Box cover (die).

The Radar Junction Box cover tool was similarly constructed. The tool heating elements were twisted 16 gage strands; their configuration in the boxed mold is shown in Figures 6 and 7. The rod shown protruding above the center of the punch mold (Figure 7) was to provide a hole for insertion of a thermoswitch. A similar thermoswitch hole was provided in the die casting. The castable used with this tool was fused silica "Masrock".(1) The tool was heated to 1900°F to mature the cement. No cracking was observed when the tool was mounted in the press.

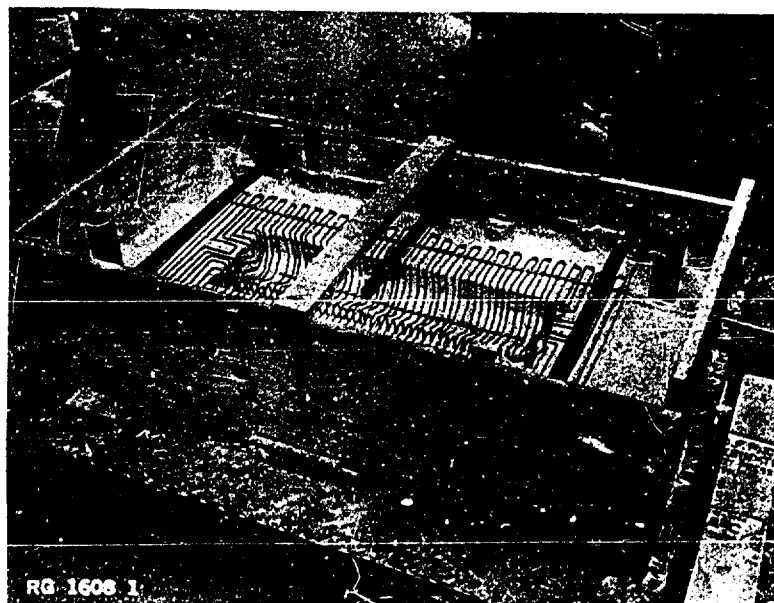
Fig. 7

Box mold assembly of Radar Junction Box cover
(punch). Phenolic rod in the center provides for
thermoswitch installation.

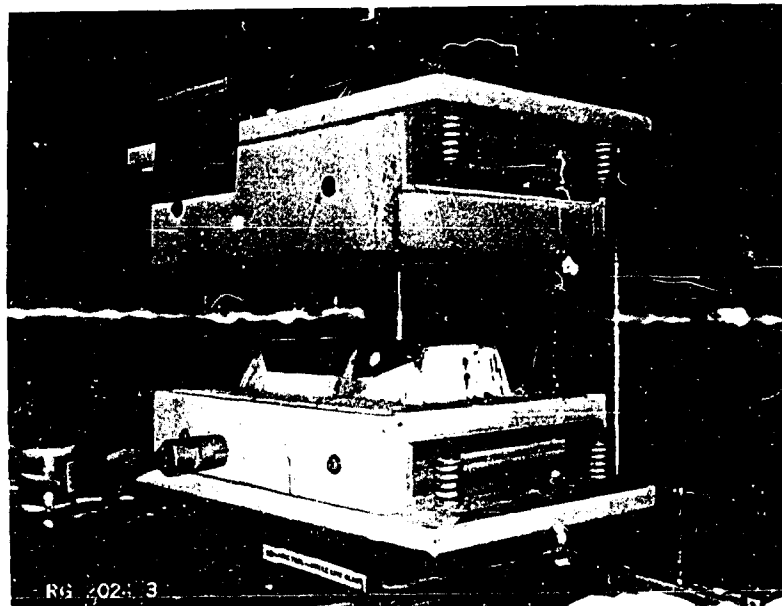
Fig. 9

Embedded element hot sizing die mounted in production press.

The new tool was evaluated on a production order of 77 parts. Figure 9 is a photograph of the tool in the press during the production run. At the completion of the order, tool wear was evident in several places. The punch had a large chip in the back flange, (see Figure 10). Both of the beads in the die were broken, one before (due to faulty handling) and one during the production run. Also, one entire side of the die (female) had cracked. None of these defects adversely affected the part quality as they were "out of part".

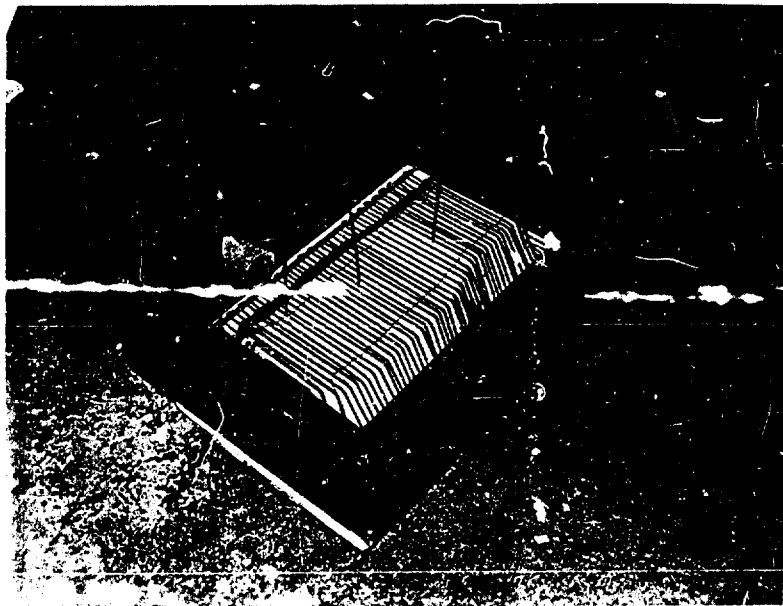
Fig. 11A

Steel box and heating elements on mold in
preparation for casting.

The punch has been repaired by methods indicated in previous reports, and the die replaced. Several important changes have been incorporated in the new die. First, the tool has been encased in a steel box. It is felt that if the die should crack on a future production order, the box would hold the parts of the die in their places. In addition, the box has simplified the procedure of attaching the tool to the die set. Second, the heating elements were welded together before the new die was cast. In this manner, the joints are no longer exposed to the air. Third, the size of the bead on the die was increased to its maximum tolerance limit to aid in the removal of the wrinkle left by the preform operation. The top of the beads have also been rounded to prevent their frequent breakage. Figures 11A and B are photographs of the new die.

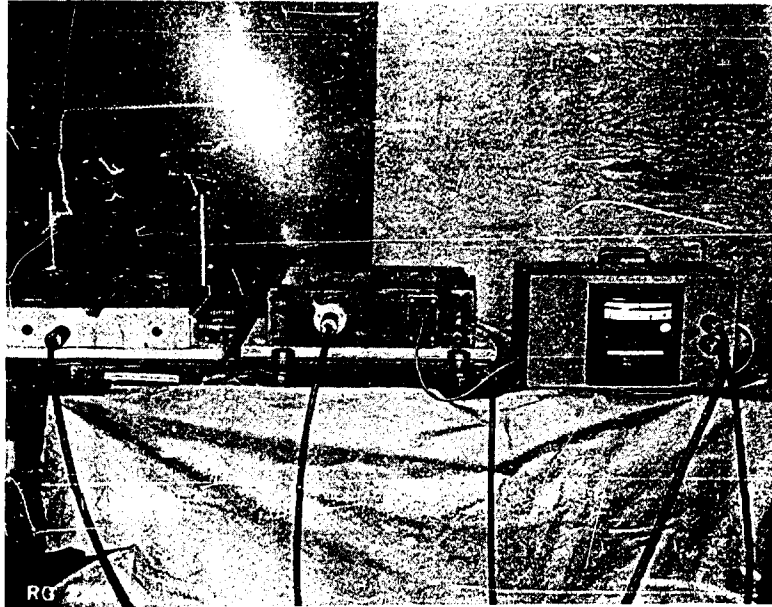
Fig. 11B

Finished hot sizing tool with temperature controller.
Only the die is boxed.

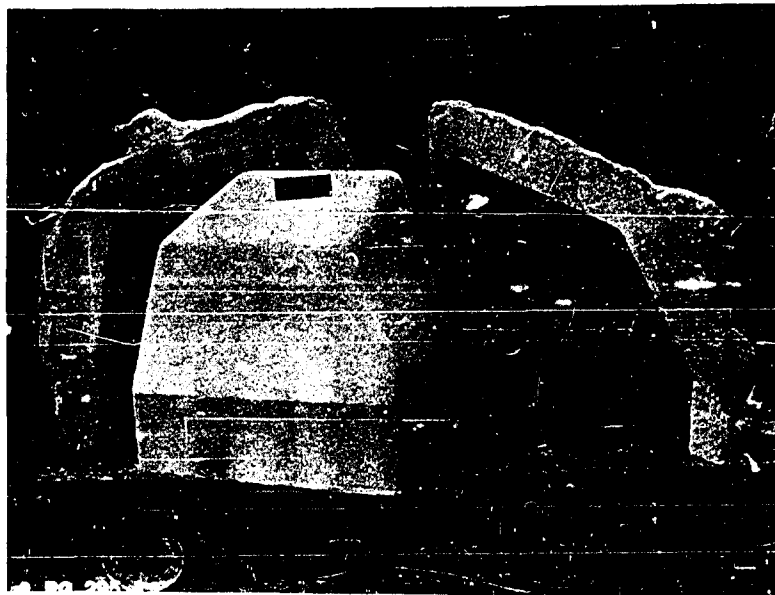
Fig. 12

Mold and casting of Radio Compartment tool.

The casting and mold are shown in Figure 12. A closeup of surface bubble holes in this casting is shown in Figure 13. These holes were prevalent on vertical surfaces only.

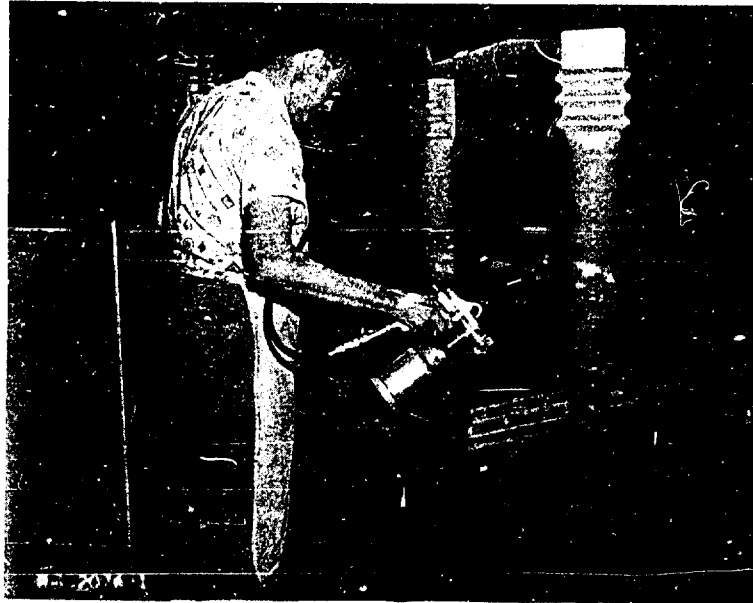
Fig. 15

Thalco parting agent solution is sprayed over working surfaces. The Thalco dries to a film after 10 minutes at 250°F. A coating of Simonize wax is applied over the Thalco film.

The Junction Box LUB was the tool used in the following pictorial series (Figures 15 - 25) describing the layup process.

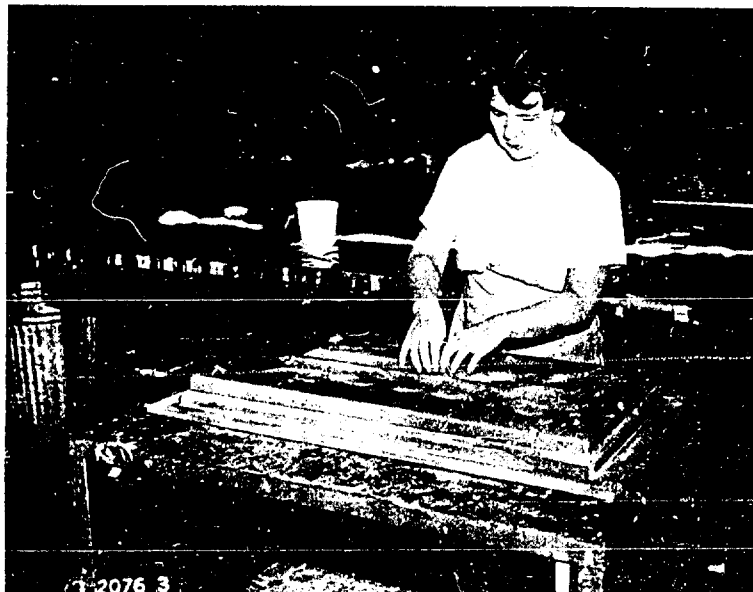
Fig. 16

Resin impregnated cloth is laid on the tool and the wrinkles removed.

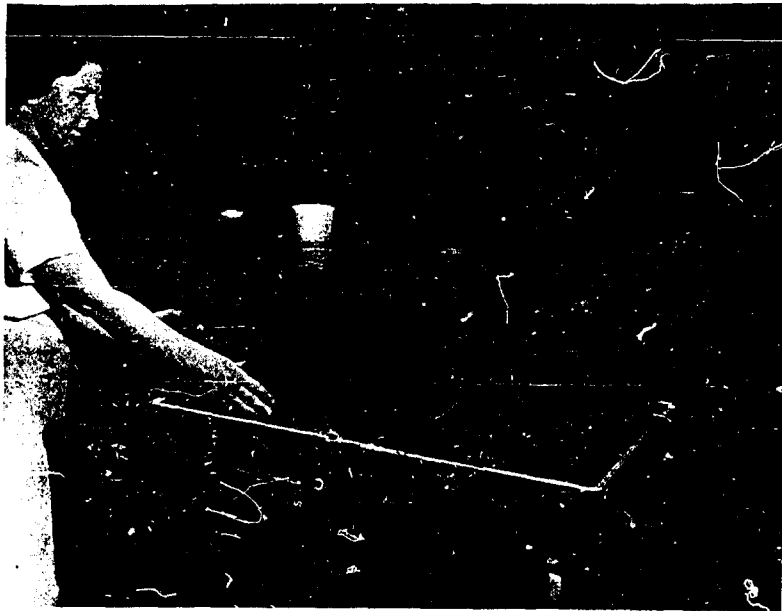
Fig. 17

The bottom of the tool is cleaned with Naptha and a Chromate-putty strip is applied around the bottom. Two layers of felt stripping is wrapped about the tool just inside the puttied area.

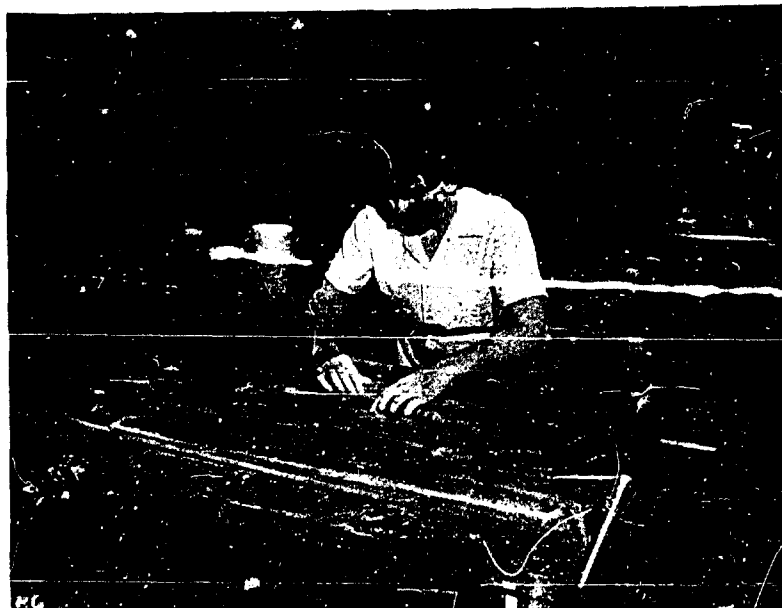
Fig. 18

A sheet of PVA (polyvinyl alcohol) is laid over the LUB and wrinkles removed. The sheet is held down by the putty ring. Additional putty is applied to help form an airtight PVA bag.

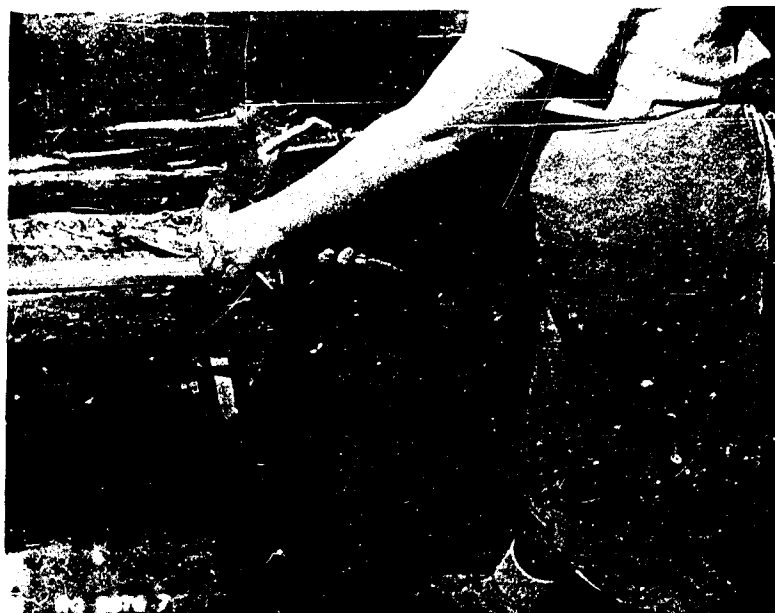
Fig. 19

A vacuum is pulled in the bag.

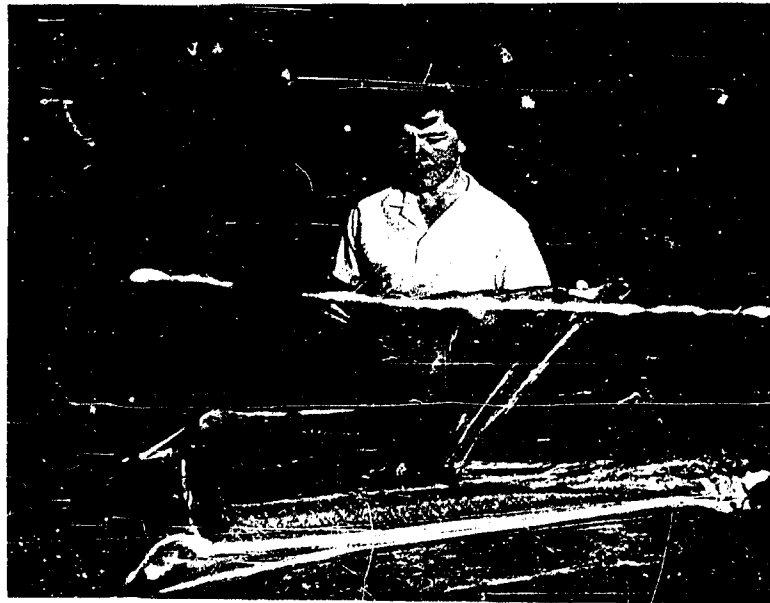
Fig. 22

After the curing cycle the bag is cut and pulled away.

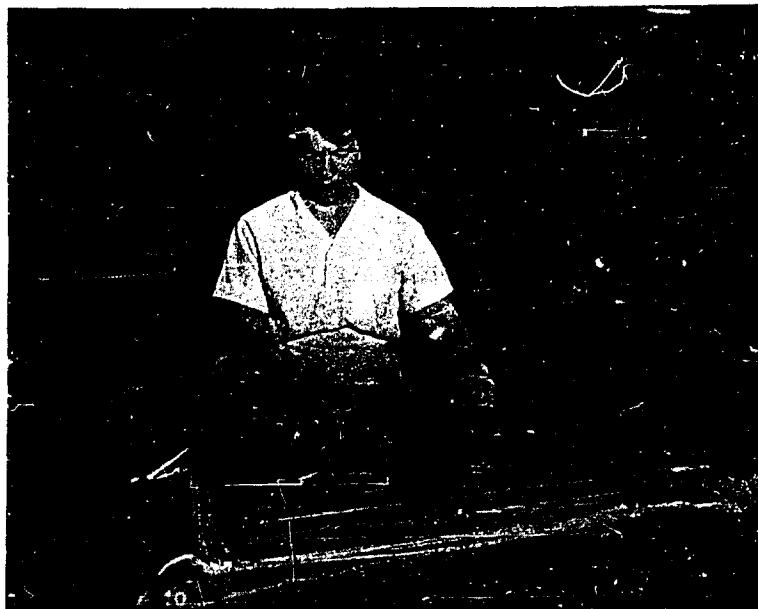
Fig. 23

The part is removed from the tool with the aid of phenolic scrapers and compressed air.

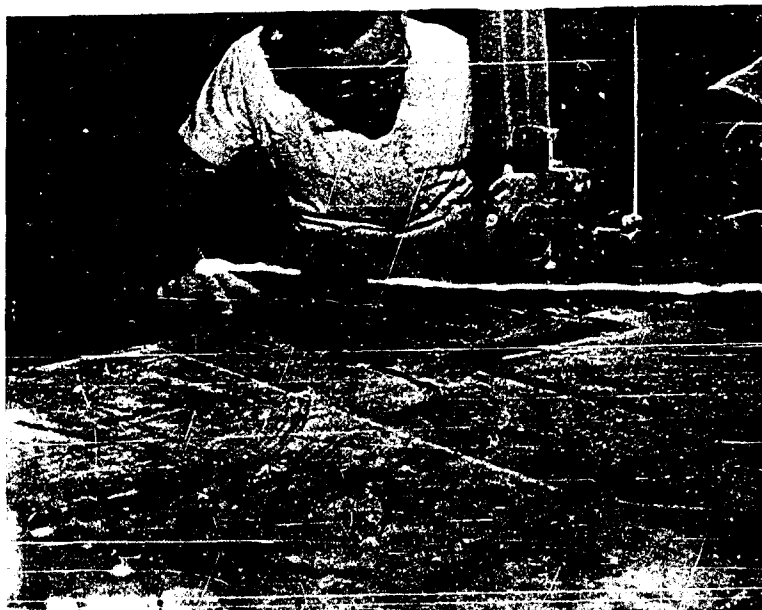
Fig. 24

The part is then trimmed to required dimension. Trimming is usually done with a trim fixture and a router, though use of a band saw is acceptable.

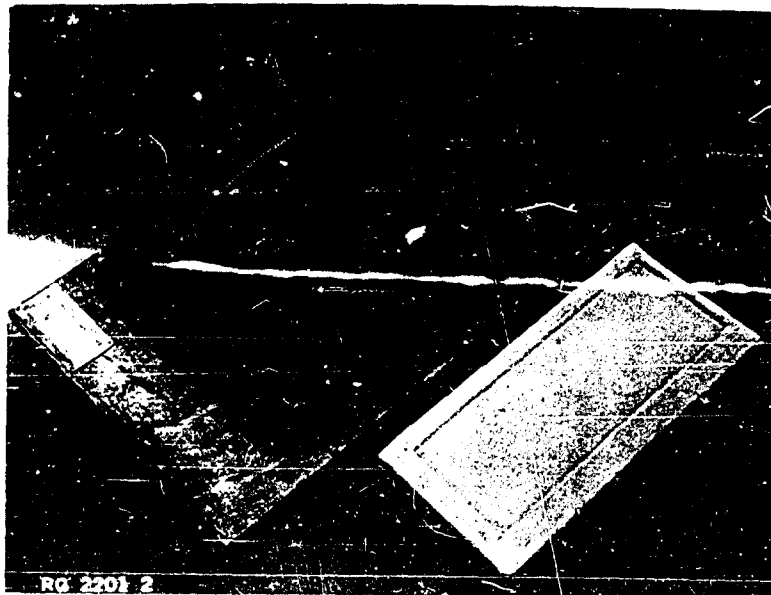
Fig. 26

Power assembly cover LUB and trimmed part.

A layup block to form part 3B10367 (Power Assembly Cover) was constructed in the same manner as the above tool. This tool, however, was potted to a steel plate. Seven production parts have been formed on this tool. The LUB is shown in Figure 26.

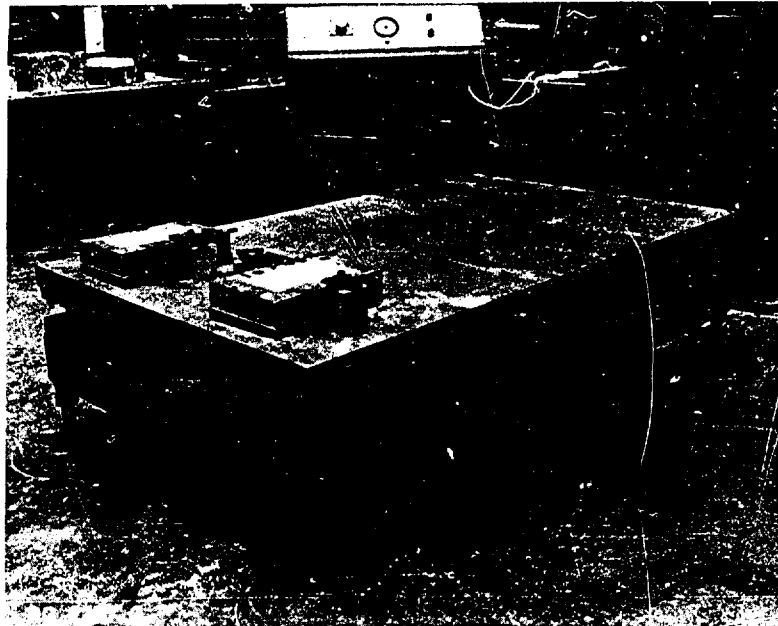
Fig. 27

Vibrating table and console. Brick size castings
are mounted for vibrating.

To facilitate bubble removal from castings a large, variable frequency vibrating table was constructed. The steel table had a working area of 48" x 80" and a nominal load limit of 1000 pounds. An eccentric weight type mechanism produced sinusoidal table movement and permitted frequency variation from 0-60 cycles/sec. The mechanism was driven by 1.5 hp motor. The vibration amplitude was adjustable (within limits) being dependent on the load.

The vibrating table and console are shown in Figure 27.

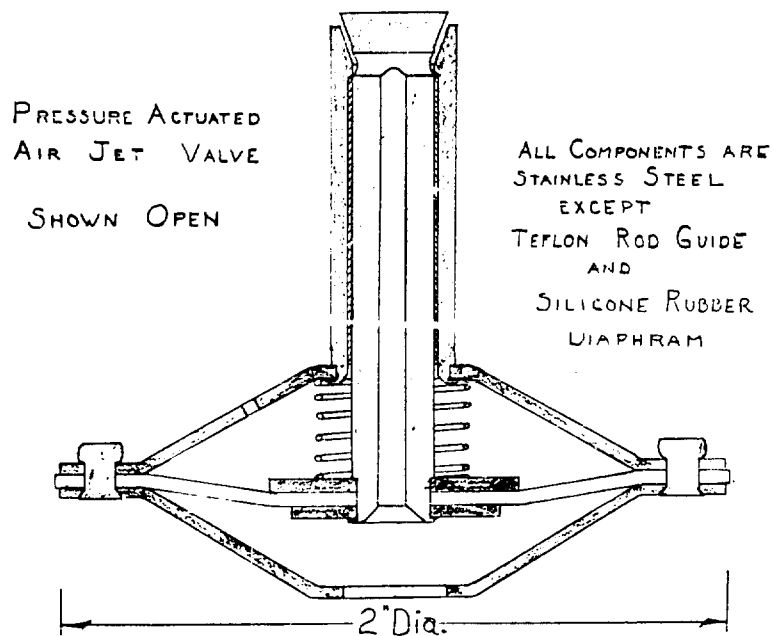
Fig. 28

New Air jet valve.

A pressure actuated air jet valve was developed for use in molding dies to facilitate plastic part removal. This valve cannot be blocked by resin flow under hydraulic pressure when the molding die is closed. The valve is easily potted or cast flush with the working surface of the tool. A description of the valve is shown in Figure 27.
